Appendix D Vibration testing results and instrumentation

Appendix E Architectural heritage report

RE: HERITAGE ADVICE ON NOISE REDUCTION MITIGATION MEASURES
ASSOCIATED WITH WINDSOR BRIDGE REPLACEMENT PROJECT

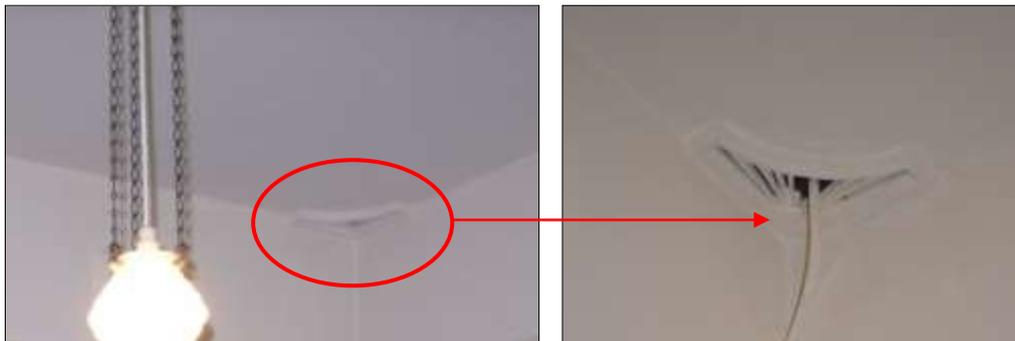
consultant in order to establish the locations for ducting registers. Images of an example of traditional corner ceiling vent, taken by the author from a house in Alexandria, have been provided below for reference. New detailing should not imitate this example but be a simple version of the traditional ceiling vent.

The ventilation system ducts / cabling can be placed within the roof cavity with only minimum required opening for the ducting registers at the agreed points of the ceilings. Consultation should be undertaken with an appropriately qualified heritage

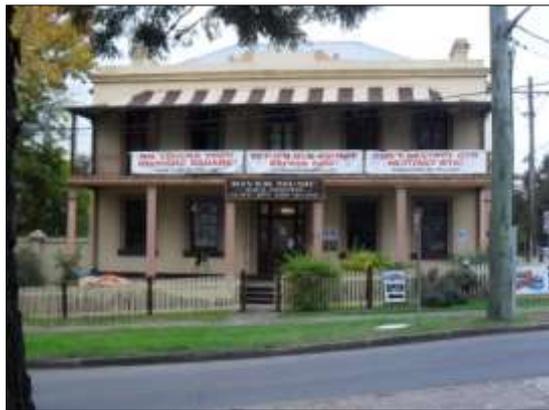
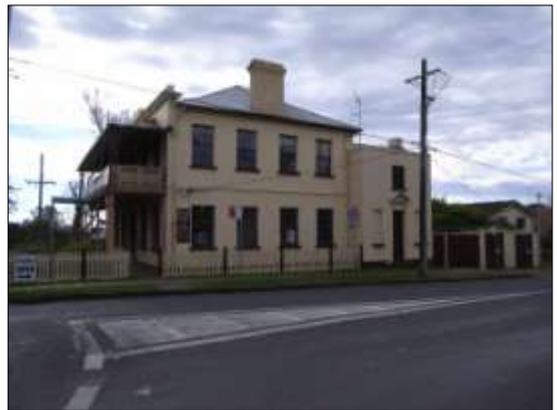
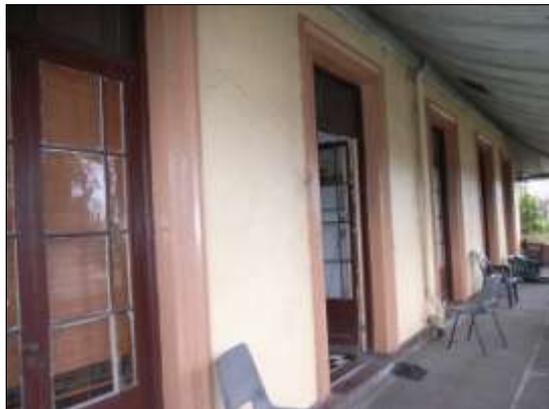
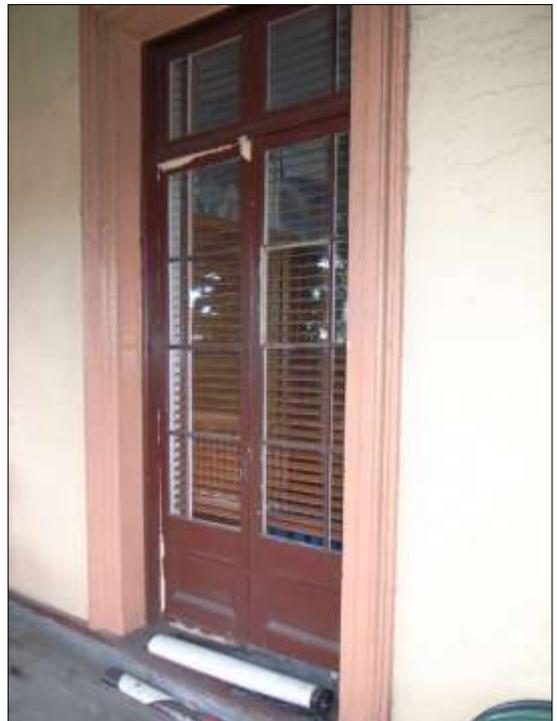
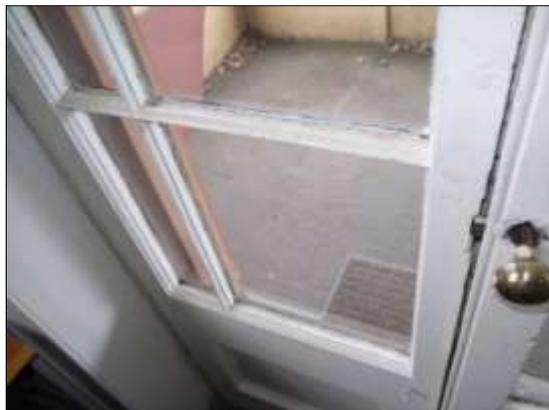
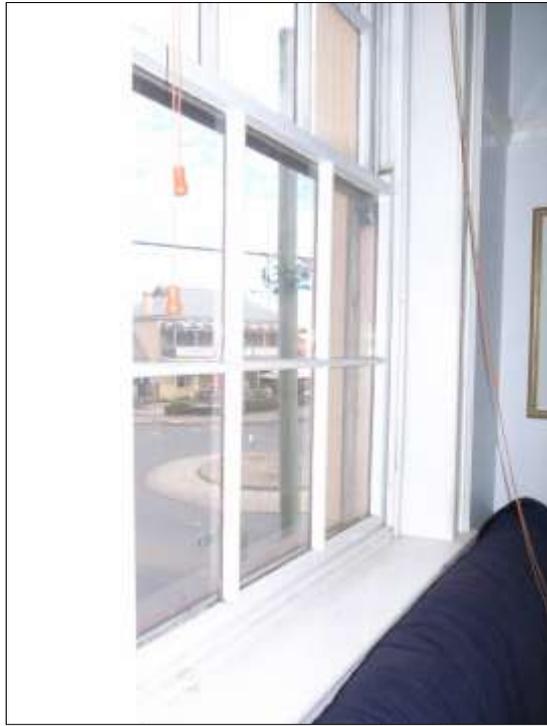
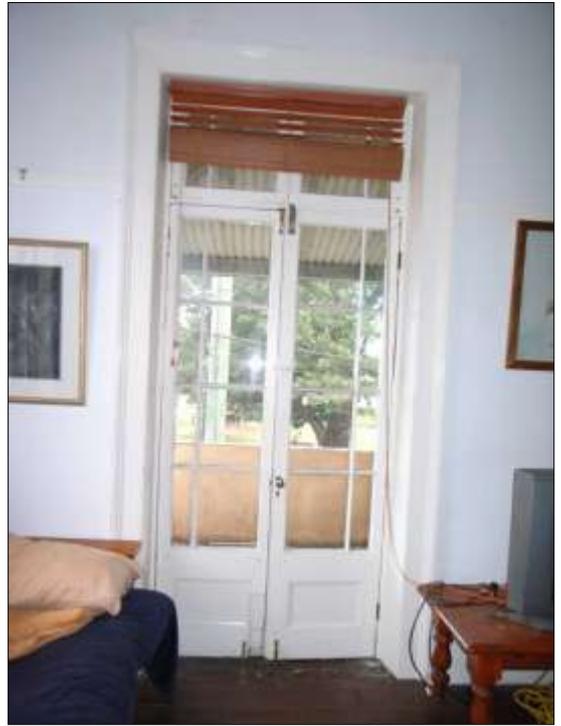
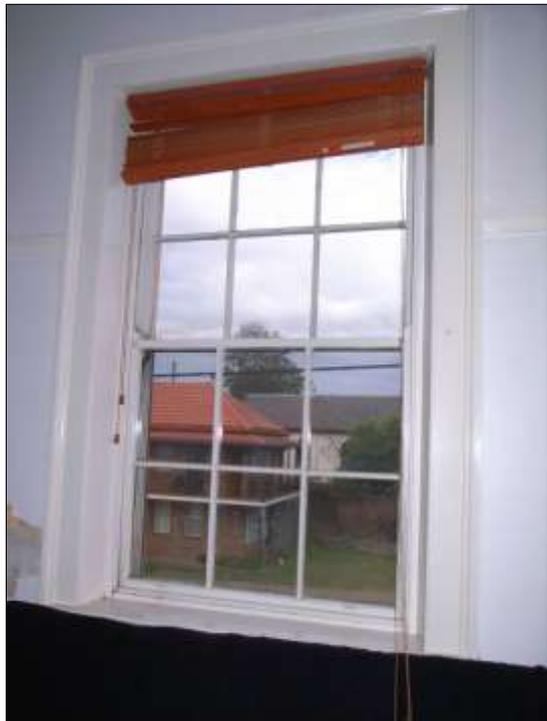
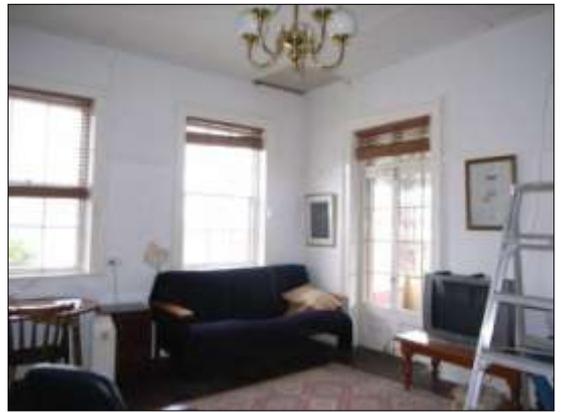
The subject house features highly intact timber door and window joinery to both ground and first floor main street facades. The windows to both levels are timber framed multi-paned double-hung windows with six-pane to each sash. The main street facade windows have deep splayed reveals.

The upper residential part of the premises features five (5) French doors opening onto the front timber balcony from each room facing Bridge Street. Each room on the upper level is rented to individual tenants and with the exception of the corner room the remainder of the rooms on bridge Street facade rely only on the French doors for ventilation and daylight. Therefore mitigation measures need to consider this constraint and allow for easy operation of the doors. The French doors feature four glazed panels with margin glazing to each door leaf and a fanlight above also with margin glazing. The majority of the existing glazing is original.

Similarly, the upper floor rooms facing George Street feature four (4) windows (2 to each room). All windows are operable and should be retained in operational condition. The profile of the existing glazing bars of the timber joinery (both French doors and windows) is very fine with a deep section that would allow insertion of a second custom made frame.

Views of the existing French doors and windows on the upper level of 10 Bridge Street, Windsor including external street views

Given consideration to the streetscape and internal presentation and importance of the existing joinery, it is thought that custom made individual glazed timber framed panels (Option 4 for windows and Option 3 for French doors) will be the most appropriate treatment. The custom made frames will create double glazing with air cavity sealed and fitted without any damage to the existing original glazing panels. The appearance of the joinery will be the same from both inside and outside thus aesthetic significance of the heritage item will not be affected. Furthermore the new frames can be removed without damage to the existing fabric if require in the feature.

Based on the above discussion the custom made individual glazed panels option will be our preferred option. It is recommended that an experienced carpenter with traditional joinery expertise be engaged to undertake a detailed inspection and measurement of the subject window and French doors joinery for the design of the most appropriate timber frame profile and sealant requirements to fit without any need for screw/nail fixing.
